Manhole Inspection Summary

Manhole # S39GG_002MH

Insp Date: **3/29/07 1:16 PM**

Location Address: **1301 WILCOX ST**

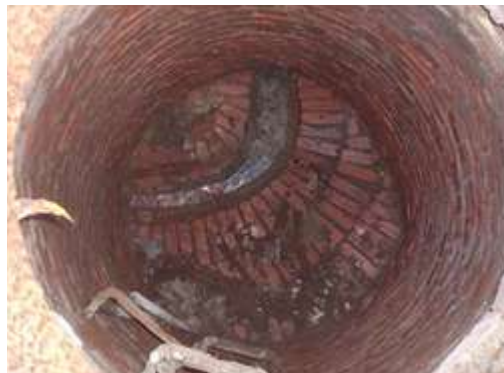
Top View

Corroded and missing steps. Evidence of surcharge - Bench debris. Channel debris.

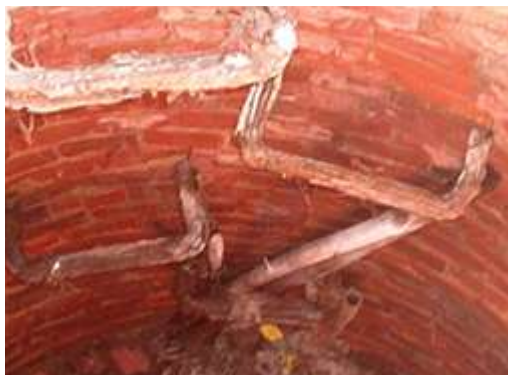
Defect

Infiltration: ☐ None ☐ Joint ☐ Cracks ☐ Mortar ☐ Roots ☒ **Wall**

Corbel and Barrel infiltration.

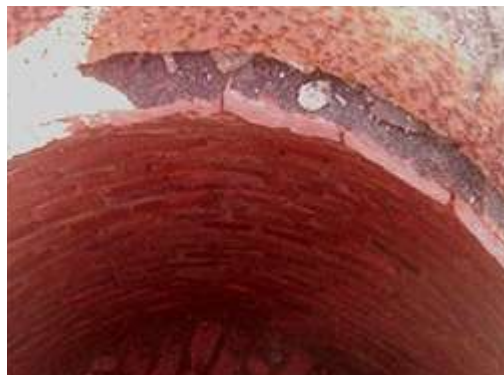
Defect

Frame Offset: **2** (in.) Condition: ☒ Sound ☐ Cracked ☐ Leaks

Condition: ☐ Sound ☐ Cracked ☐ Root Intrusion ☐ Loose Brick ☒ **Deteriorated**

Infiltration: ☐ None ☒ **Joint** ☐ Cracks ☐ Mortar ☐ Roots ☒ **Wall**

Frame offset. Adjustment deterioration and infiltration.

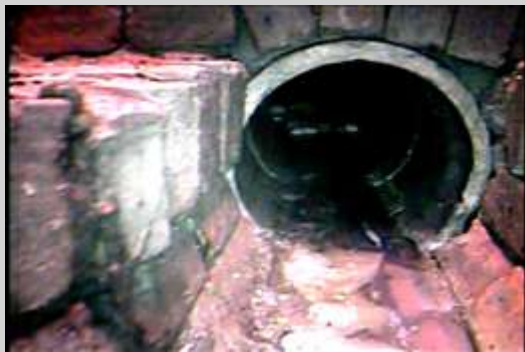
8 in. Circular Gravity Sewer Pipe Out @ 12 O'Clock

Channel deterioration.

Deposits: ☐ None ☐ Mud ☐ Sludge ☐ Debris ☒ **Grease**

Silt Depth: **0** (in.) Deposits Extent: **Light**

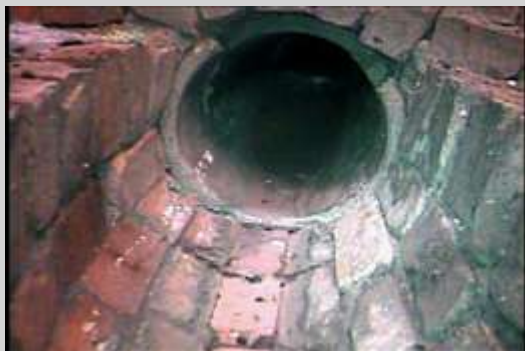
8 in. Circular Gravity Sewer Pipe In @ 9 O'Clock

Deposits: ☐ None ☐ Mud ☐ Sludge ☐ Debris ☒ **Grease**

Infiltration: **Evidence** Pipe Seal Cond: **Broken**
